**Flood Control Project Maintenance**  
**2018 Structure Summary Report**  
**Overall Unit and Item Ratings**

**Madera County FCWCA**

**Ash Slough Control Structure**

**Flood Control Project Maintenance**  
**Unit Cover Sheet**  
**2018 Structure Inspection Results**

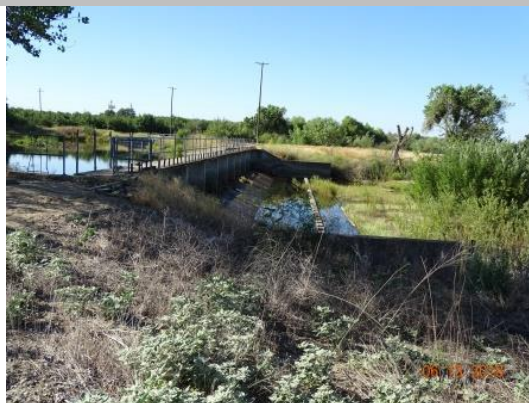
Photo 1 of 5 : ST\_2018\_NA0011\_68\_1\_20180615\_00015.jpg

View looking upstream at the whole structure. (2018)

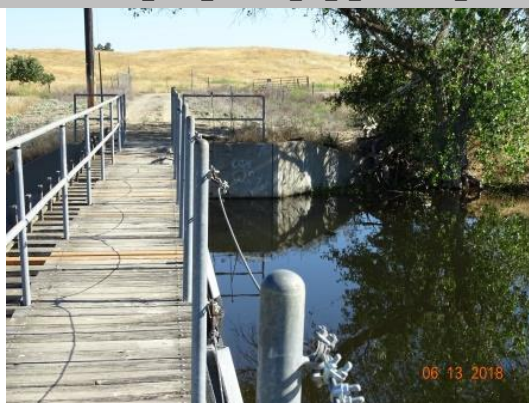
Photo 2 of 5 : ST\_2018\_NA0011\_68\_1\_20180615\_00016.jpg

Upstream right bank view of the wing wall and walk way. (2018)

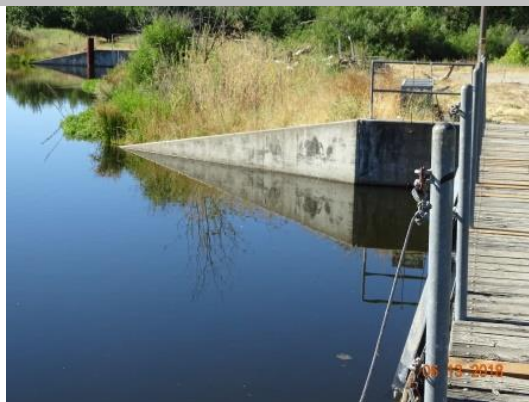
Photo 3 of 5 : ST\_2018\_NA0011\_68\_1\_20180615\_00017.jpg

Upstream left bank view of the wing wall and walk way. (2018)

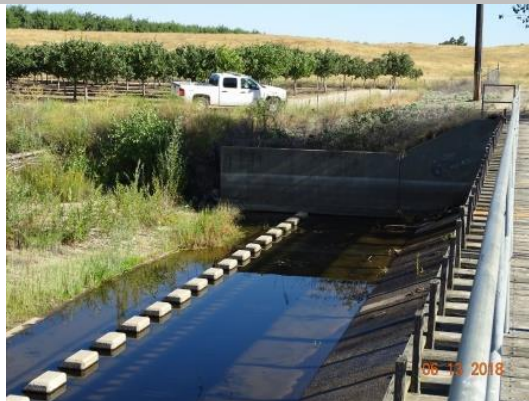
Photo 4 of 5 : ST\_2018\_NA0011\_68\_1\_20180615\_00018.jpg

Downstream right bank view of the concrete wall, weir, hydraulic dissipator, and walk way. (2018)

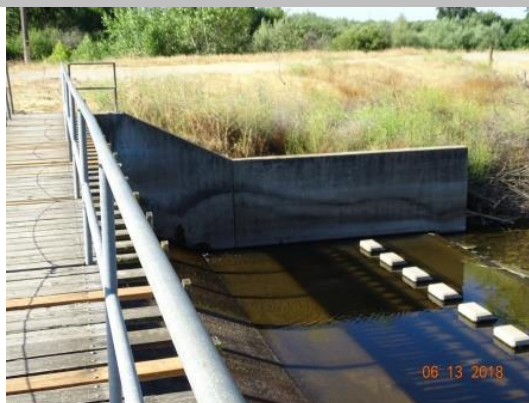
Photo 5 of 5 : ST\_2018\_NA0011\_68\_1\_20180615\_00019.jpg

Downstream left bank view of the concrete wall, weir, hydraulic dissipator, and walk way. (2018)

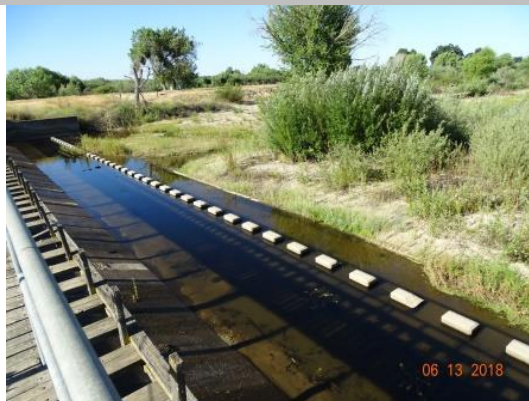
Photo 1 of 1 : ST\_2018\_NA0011\_68\_2\_20180615\_00020.jpg

LM Start	0.00	Rating **	A	Issue No.	2
LM End	0.00	Issue Type +	Ma	Location *	WS
Category	Structures & Concrete Lined Channels			GPS Latitude/Longitude	
				Start	End
Item	Vegetation & Obstructions			37.158598 °	37.158598 °
				-120.124531 °	-120.124531 °
DWR ID	DWR_NA0011_68_t_2017_2				
Action/Comments					
Inspector Comments: Minimal amount of vegetation present on the right bank downstream from structure. The flow is not impeded.

Vegetation directly downstream of the structure. (2018)

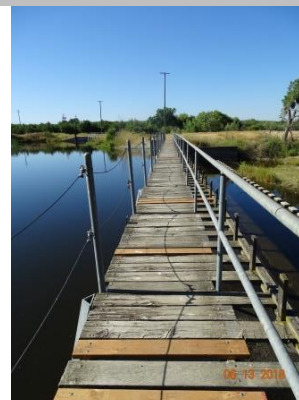
Photo 1 of 2 : ST\_2018\_NA0011\_68\_23\_20180615\_00023.jpg

LM Start	0.00	Rating **	M	Issue No.	23
LM End	0.00	Issue Type +	Ma	Location *	WS
Category	Structures & Concrete Lined Channels	GPS Latitude/Longitude			
		Start	End		
Item	Safety	37.158598 °		37.158598 °	
		-120.124531 °		-120.124531 °	
DWR ID	DWR_NA0011_68_t_2017_23				
Action/Comments					
Inspector Comments: Damaged boards have been replaced. Cable holding hand railing at left end of walkway is missing.

View of replaced boards on walk way. (2018)

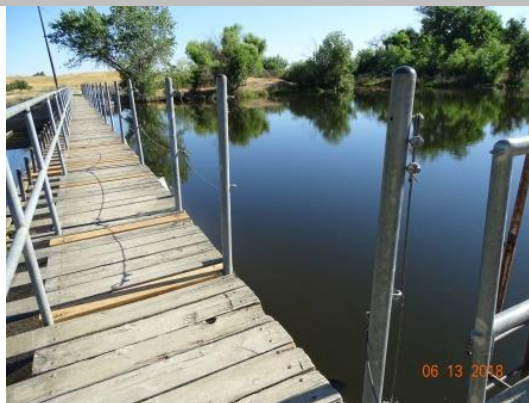
Photo 2 of 2 : ST\_2018\_NA0011\_68\_23\_20180615\_00022.jpg

LM Start	0.00	Rating **	M	Issue No.	23 (cont)
LM End	0.00	Issue Type +	Ma	Location *	WS
Category	Structures & Concrete Lined Channels	GPS Latitude/Longitude			
		Start		End	
Item	Safety	37.158598 °		37.158598 °	
		-120.124531 °		-120.124531 °	
DWR ID	DWR_NA0011_68_t_2017_23				
Action/Comments					
Inspector Comments: Damaged boards have been replaced. Cable holding hand railing at left end of walkway is missing.

View of missing walkway cable. (2018)

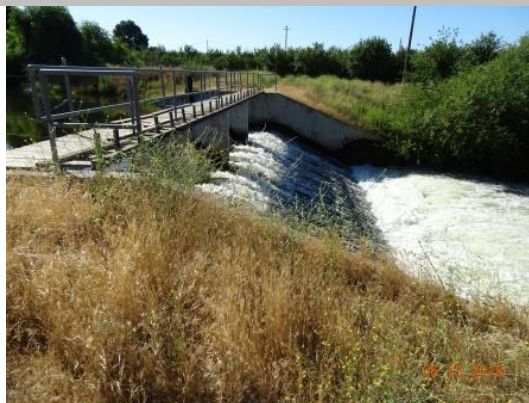
Photo 1 of 5 : ST\_2018\_NA0011\_69\_1\_20180615\_00005.jpg

Looking upstream at the whole structure. (2018)

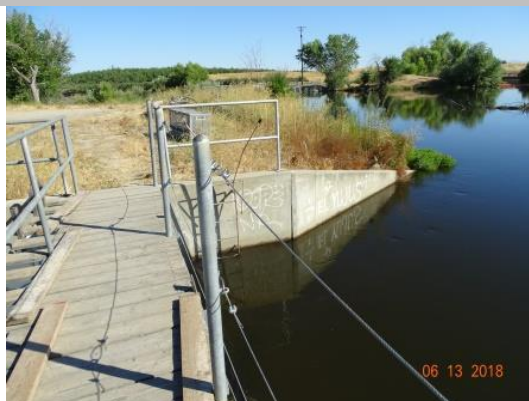
Photo 2 of 5 : ST\_2018\_NA0011\_69\_1\_20180615\_00006.jpg

Upstream right bank view of wing wall and walk way. (2018)

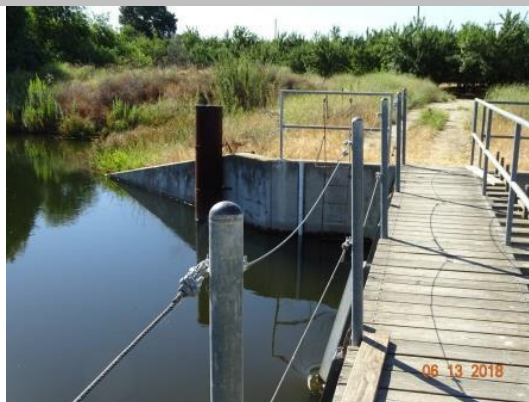
Photo 3 of 5 : ST\_2018\_NA0011\_69\_1\_20180615\_00007.jpg

Upstream left bank view of wing wall and walk way. (2018)

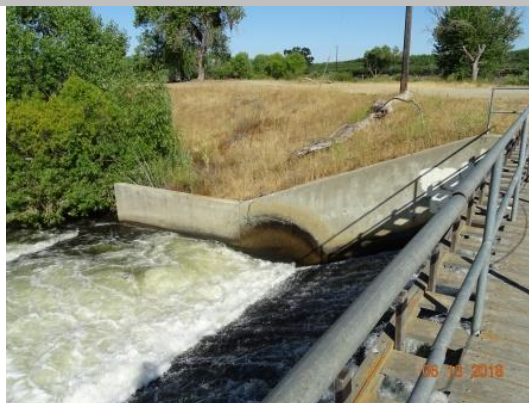
Photo 4 of 5 : ST\_2018\_NA0011\_69\_1\_20180615\_00008.jpg

Downstream right bank view of concrete wall, walk way, and weir. (2018)

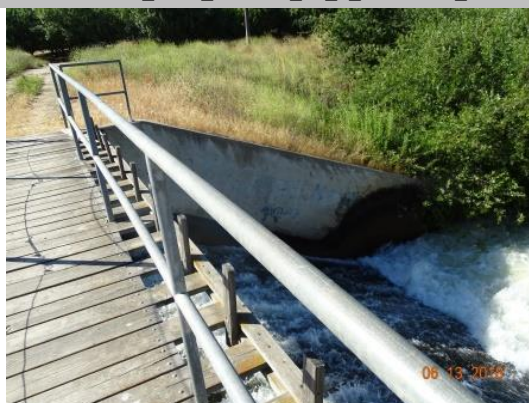
Photo 5 of 5 : ST\_2018\_NA0011\_69\_1\_20180615\_00009.jpg

Downstream left bank view of concrete wall, walk way, and weir. (2018)

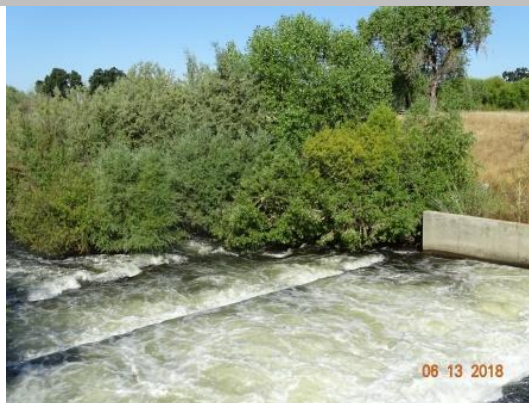
Photo 1 of 1 : ST\_2018\_NA0011\_69\_2\_20180615\_00010.jpg

LM Start	0.00	Rating **	A	Issue No.	2	
LM End	0.00	Issue Type +	Ma	Location *		
Category	Structures & Concrete Lined Channels			GPS Latitude/Longitude		
				Start	End	
Item	Vegetation & Obstructions			37.158013 °	37.158013 °	
				-120.124174 °	-120.124174 °	
DWR ID	DWR_NA0011_69_t_2017_2					
Action/Comments						
Inspector Comments: Looking downstream from the structure there is a small scattered amount of vegetation present on the right bank that does not impede the flow. However, vegetation should be controlled before it becomes a problem.

View of downstream right bank vegetation. (2018)

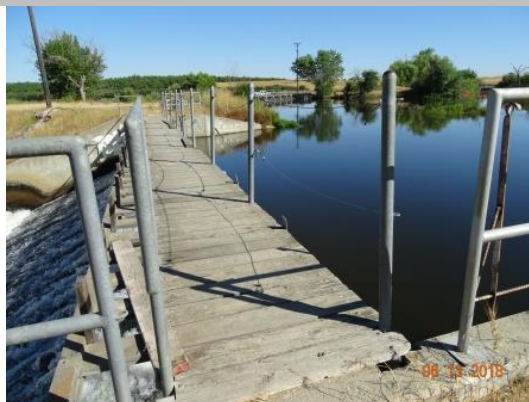
Photo 1 of 2 : ST\_2018\_NA0011\_69\_23\_20180615\_00011.jpg

LM Start	0.00	Rating **	A	Issue No.	23
LM End	0.00	Issue Type +	Ma	Location *	
Category	Structures & Concrete Lined Channels			GPS Latitude/Longitude	
				Start	End
Item	Safety			37.158013 °	37.158013 °
				-120.124174 °	-120.124174 °
DWR ID	DWR_NA0011_69_t_2017_23				
Action/Comments					
Inspector Comments: Pedestrian hand railing with missing cable has been repaired..

View of repaired railing and cable on walkway. (2018)

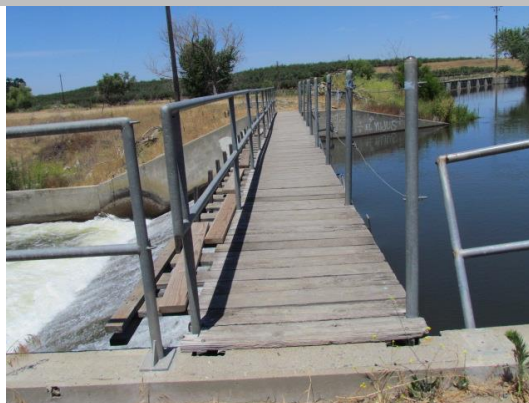
Photo 2 of 2 : ST\_2018\_NA0011\_69\_23\_20180607\_00004.jpg

LM Start	0.00	Rating **	A	Issue No.	23 (cont)	
LM End	0.00	Issue Type +	Ma	Location *		
Category	Structures & Concrete Lined Channels			GPS Latitude/Longitude		
				Start		End
Item	Safety			37.158013 °		37.158013 °
				-120.124174 °		-120.124174 °
DWR ID	DWR_NA0011_69_t_2017_23					
Action/Comments						
Inspector Comments: Pedestrian hand railing with missing cable has been repaired..

Looking at the pedestrian walkway with safety hand railing, and wooden walkway. The end piece has come apart on the upstream side of structure viewed in this photo.

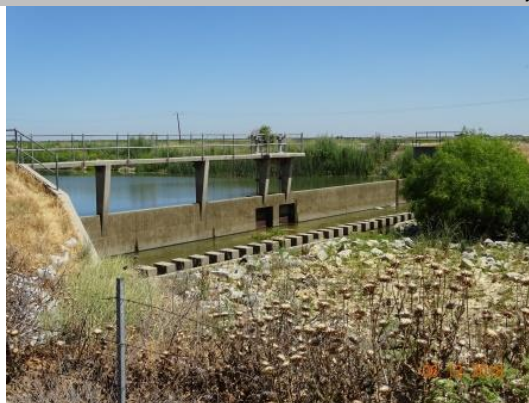
Photo 1 of 5 : ST\_2018\_NA0011\_6\_1\_20180615\_00008.jpg

Looking upstream at the whole structure. (2018)

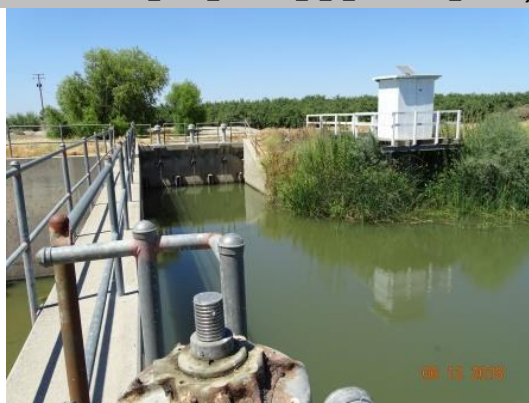
Photo 2 of 5 : ST\_2018\_NA0011\_6\_1\_20180615\_00009.jpg

Right bank upstream view the screw gate, walk way, and gauging station. (2018)

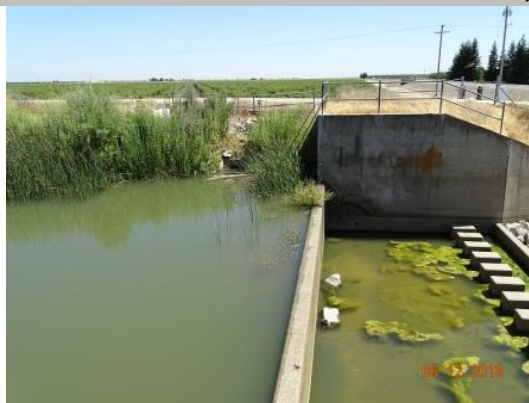
Photo 3 of 5 : ST\_2018\_NA0011\_6\_1\_20180615\_00010.jpg

Left bank upstream view of the diversion weir, wing wall, and hydraulic dissipator. (2018)

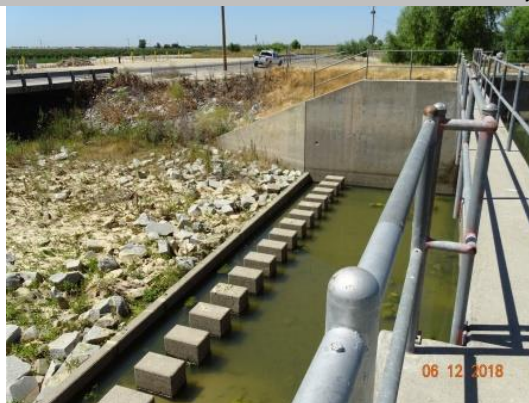
Photo 4 of 5 : ST\_2018\_NA0011\_6\_1\_20180615\_00011.jpg

Right bank downstream view of the walkway, wing wall, hydraulic dissipator, and rip rap. (2018)

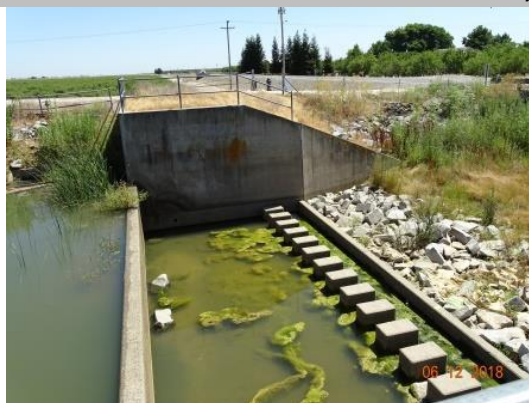
Photo 5 of 5 : ST\_2018\_NA0011\_6\_1\_20180615\_00012.jpg

Left bank downstream view of the diversion weir, wing wall, hydraulic dissipator, and rip rap. (2018)

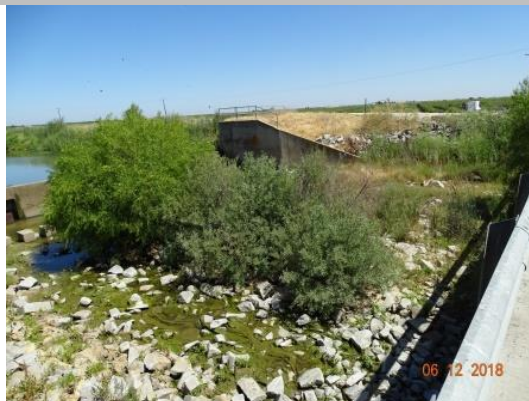
Photo 1 of 1 : ST\_2018\_NA0011\_6\_2\_20180615\_00013.jpg

LM Start	0.00	Rating **	M	Issue No.	2
LM End	0.00	Issue Type +	Ma	Location *	
Category	Structures & Concrete Lined Channels			GPS Latitude/Longitude	
				Start	End
Item	Vegetation & Obstructions			36.968221 °	36.968221 °
				-120.255523 °	-120.255523 °
DWR ID	DWR_NA0011_6_t_2016_2				
Action/Comments					
Inspector Comments: Clear trees from the downstream side of structure.

Trees directly downstream of the diversion weir. (2018)

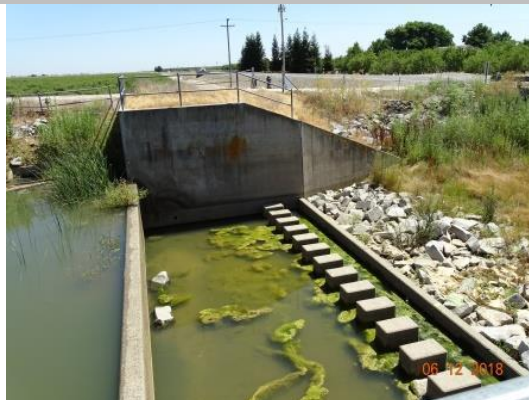
Photo 1 of 3 : ST\_2018\_NA0011\_6\_5\_20180615\_00019.jpg

LM Start	0.00	Rating **	A	Issue No.	5	
LM End	0.00	Issue Type +	Ma	Location *		
Category	Structures & Concrete Lined Channels			GPS Latitude/Longitude		
				Start		End
Item	Revetments			36.968221 °		36.968221 °
				-120.255523 °		-120.255523 °
DWR ID	DWR_NA0011_6_t_2016_5					
Action/Comments						
Inspector Comments: Revetment directly downstream of structure on both banks and in channel.

View of revetment in the channel. (2018)

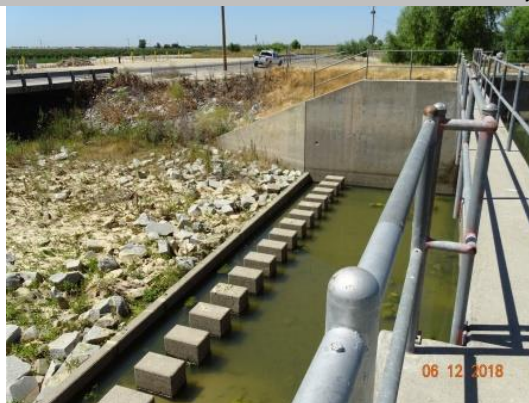
Photo 2 of 3 : ST\_2018\_NA0011\_6\_5\_20180615\_00018.jpg

LM Start	0.00	Rating **	A	Issue No.	5 (cont)	
LM End	0.00	Issue Type +	Ma	Location *		
Category	Structures & Concrete Lined Channels			GPS Latitude/Longitude		
				Start		End
Item	Revetments			36.968221 °		36.968221 °
				-120.255523 °		-120.255523 °
DWR ID	DWR_NA0011_6_t_2016_5					
Action/Comments						
Inspector Comments: Revetment directly downstream of structure on both banks and in channel.

View of revetment in the channel. (2018)

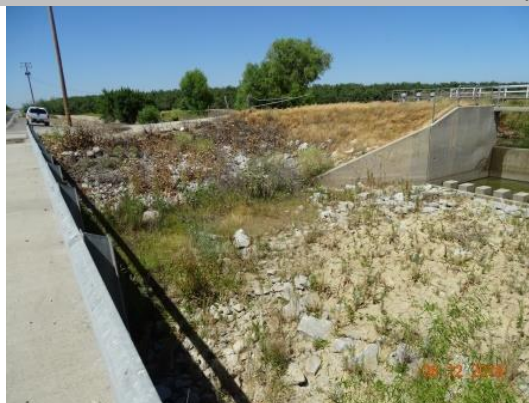
Photo 3 of 3 : ST\_2018\_NA0011\_6\_5\_20180615\_00020.jpg

Revetment on the right bank downstream of the structure. (2018)

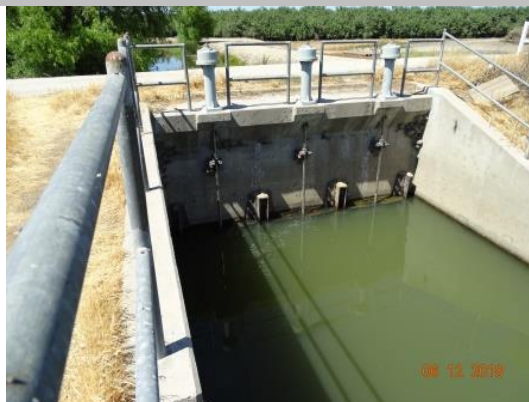
Photo 1 of 1 : ST\_2018\_NA0011\_6\_14\_20180615\_00015.jpg

LM Start	0.00	Rating **	A	Issue No.	14
LM End	0.00	Issue Type +	Ma	Location *	
Category	Structures & Concrete Lined Channels	GPS Latitude/Longitude			
		Start		End	
Item	Manual Gate Operators	36.968221 °		36.968221 °	
		-120.255523 °		-120.255523 °	
DWR ID	DWR_NA0011_6_t_2016_14				
Action/Comments					
Inspector Comments: The manual control gates here are in good working order.

Manual control gates. (2018)

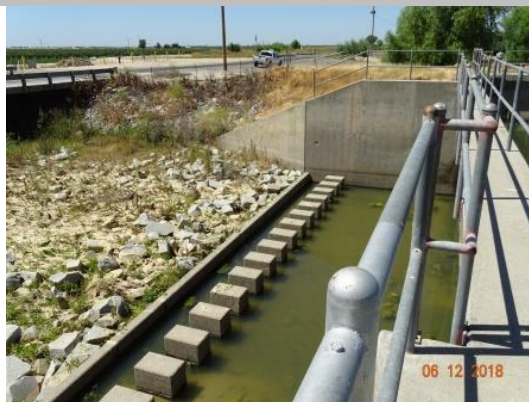
Photo 1 of 2 : ST\_2018\_NA0011\_6\_15\_20180615\_00016.jpg

LM Start	0.00	Rating **	A	Issue No.	15
LM End	0.00	Issue Type +	Ma	Location *	
Category	Structures & Concrete Lined Channels	GPS Latitude/Longitude			
		Start		End	
Item	Concrete Surfaces	36.968221 °		36.968221 °	
		-120.255523 °		-120.255523 °	
DWR ID	DWR_NA0011_6_t_2016_15				
Action/Comments					
Inspector Comments: The concrete surface here is in good condition.

Concrete surfaces show no cracks. (2018)

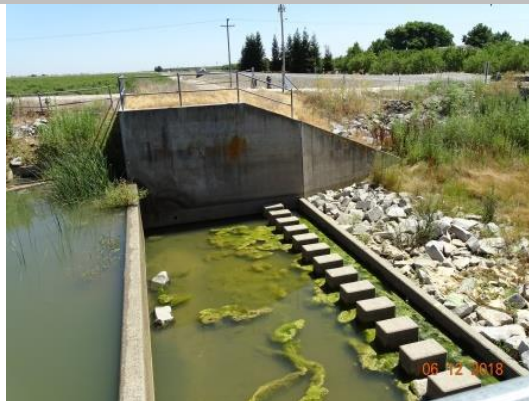
Photo 2 of 2 : ST\_2018\_NA0011\_6\_15\_20180615\_00017.jpg

LM Start	0.00	Rating **	A	Issue No.	15 (cont)	
LM End	0.00	Issue Type +	Ma	Location *		
Category	Structures & Concrete Lined Channels			GPS Latitude/Longitude		
				Start		End
Item	Concrete Surfaces			36.968221 °		36.968221 °
				-120.255523 °		-120.255523 °
DWR ID	DWR_NA0011_6_t_2016_15					
Action/Comments						
Inspector Comments: The concrete surface here is in good condition.

Concrete surfaces show no cracks. (2018)
